CERTIFICATE OF MARINE INSURANCE SURVEY

Survey Number: 14TP/S584

VESSEL NAME: MOMENTUM

TYPE OF VESSEL: FRP; Motorsailer
[Fisher 30]

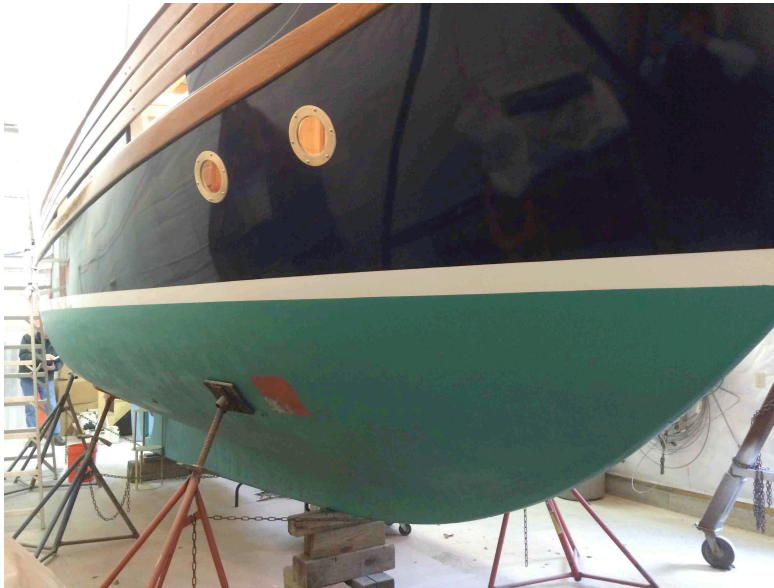
UNDERWATERBODY:

Fair & smooth, fresh anti-fouling coatings - excellent condition

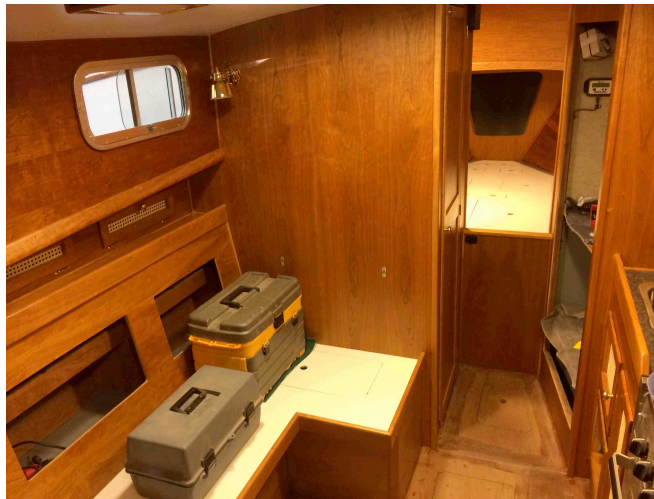
CABIN SPACES:

Clean & orderly "new" cherry finish joinery work

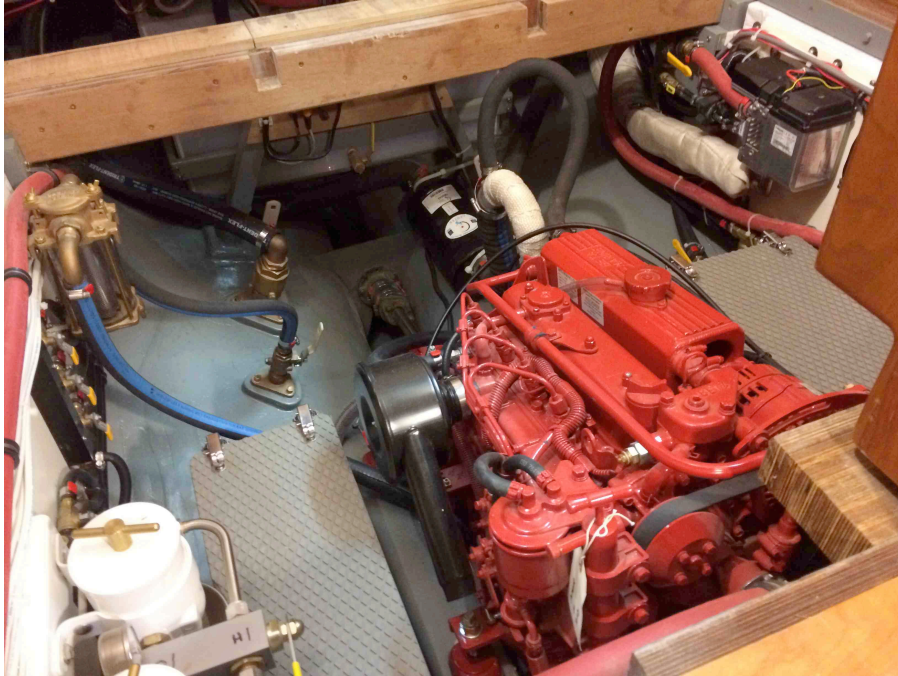
ENGINE EXHAUST SYSTEM: "New" appears well connected & gas
tight as observed

COMMENT: The vessel's auxiliary engine and machinery space were found to be in very good order. The engine was not operated during the course of the survey; therefore, no opinion is expressed regarding performance.

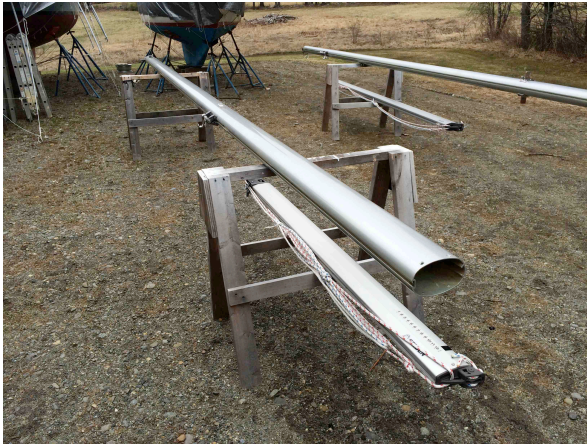
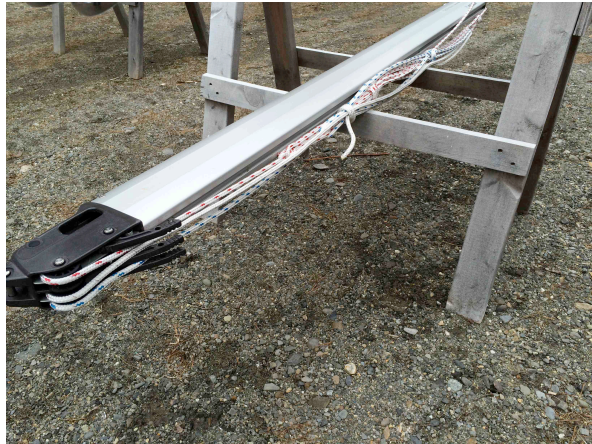
NUMBER/MATERIAL MASTS: Two (2): (1) Main & (1) Mizzen/Aluminum
CONDITION: Good condition
STANDING RIGGING: Stainless Steel Cable - good condition
as observed
RUNNING RIGGING: "New"
WINCHES: Good working order
CHAIN PLATES: Solid & well attached
SAIL INVENTORY: (1) Main & (1) Mizzen

COMMENT: Masts recently refinished and in very good condition.

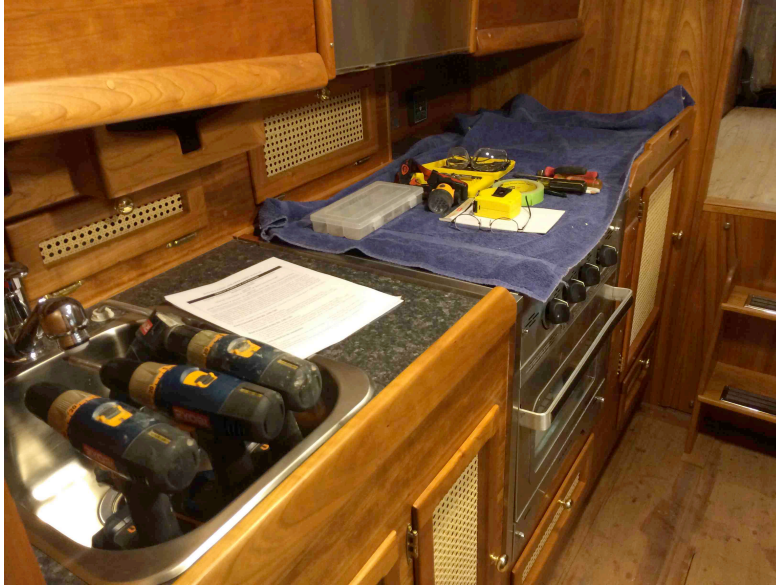
LOCATION: Starboard forward cabin
TYPE STOVE/MANUFACTURER: Three (3) Burner Stove with Oven/
DICKINSON MEDITERRANEAN
FUEL: LPG
REFRIGERATION: Engel Freezer Refrigeration System

COMMENT: The galley is complete & "new" and in good order
